SALMONID HABITAT LIMITING FACTORS WATER RESOURCE INVENTORY AREA 32 WALLA WALLA WATERSHED

FINAL REPORT
4/1/2001

Mike Kuttel, Jr.
Washington State Conservation Commission
300 Desmond Drive
Lacey, Washington 98503

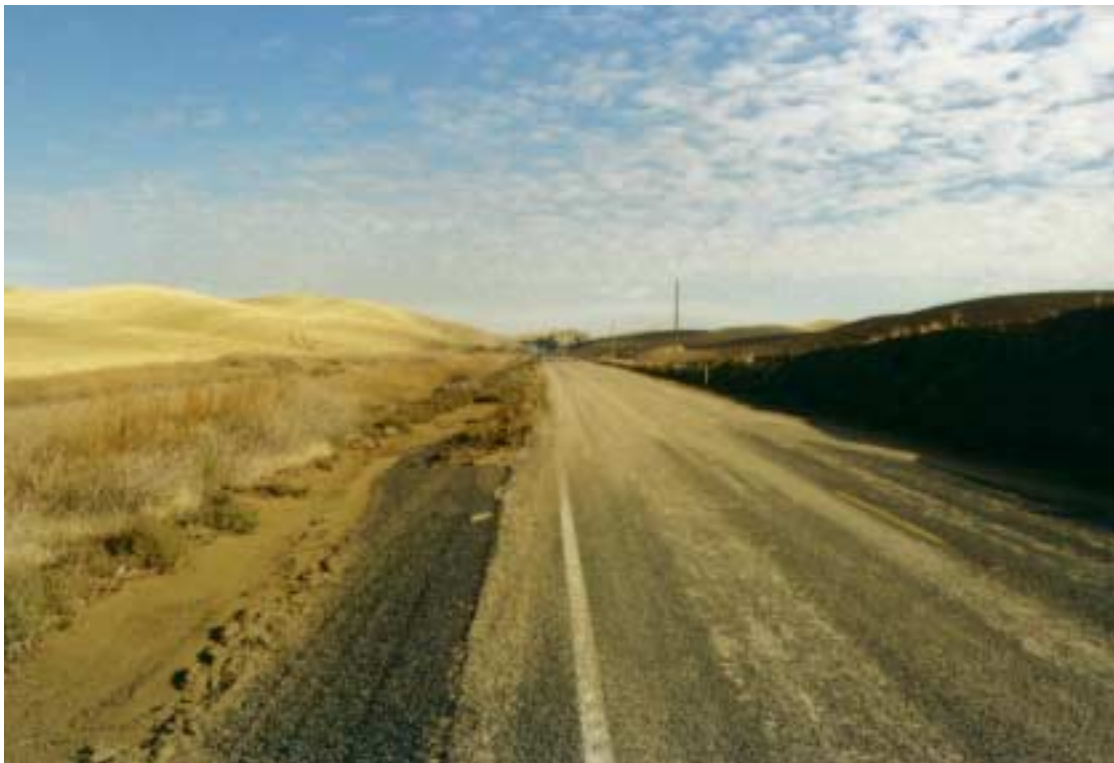
Figure 1. Mud on Hwy. 125 washed off the conventionally tilled field to the right during an early October 2000 rainstorm. Note the field to the left that is farmed with no-till methods.

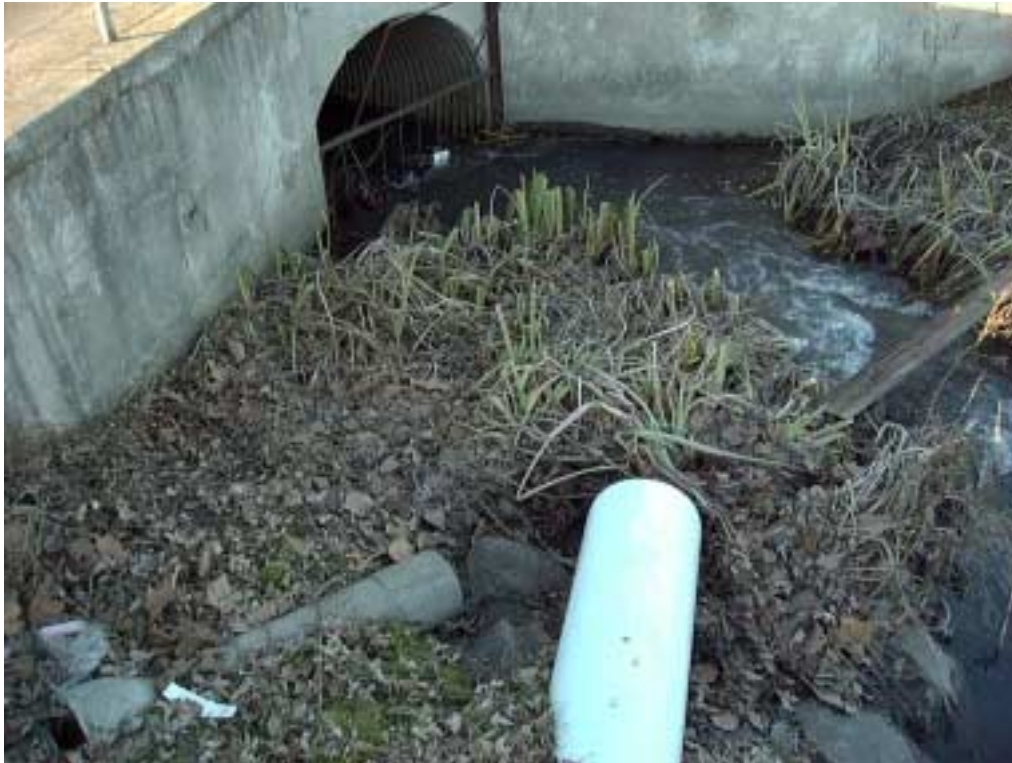
Figure 2. Culvert at the Larch Street crossing on Garrison Creek. Photo taken February 2001.

Artificial obstructions including dams and culverts can block salmonid migration up and down streams. Depending on the location and longevity of the barrier, the negative effect may be limited to a portion of only one generation, or in extreme cases the barrier may cause the extinction of an entire run of fish. Frequently encountered structures that may hinder salmonid migration in WRIA 32 include gravel push-up dams, concrete dams, and failed culverts. See [Figure 2](#) below.

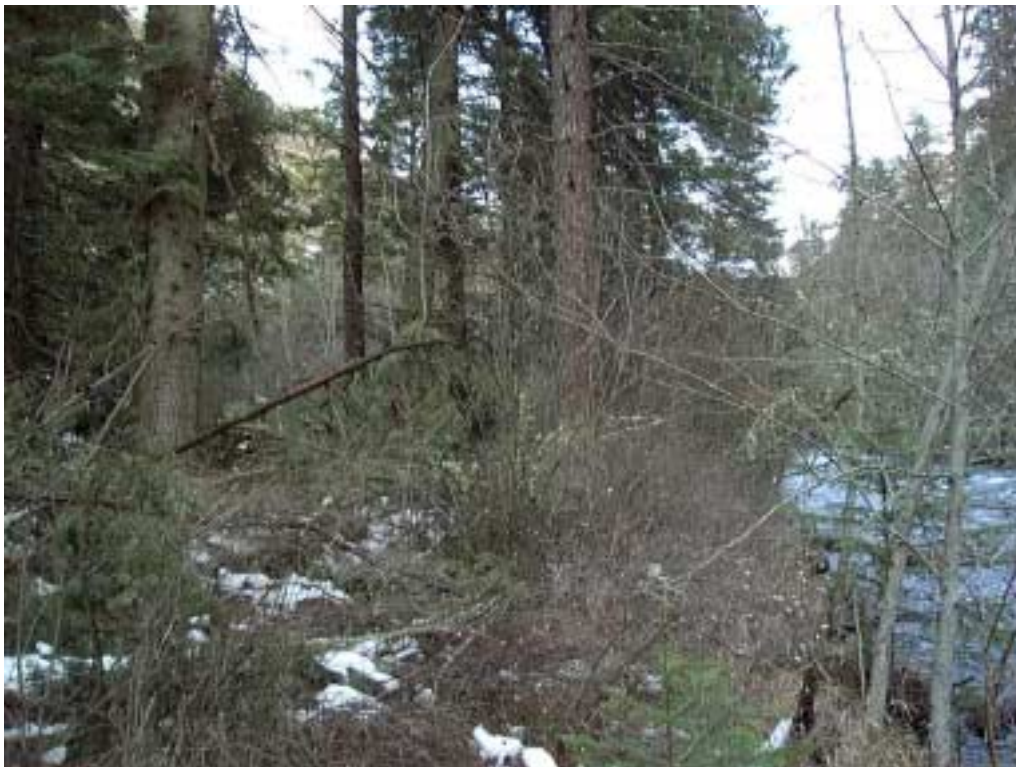
Figure 3. Riparian vegetation along the South Fork Walla Walla River on Bureau of Land Management Lands. Photo taken January 2001.

zones have several important functions in maintaining natural riverine processes. Tree and shrub roots hold streambanks together with a “root matrix.” This matrix stabilizes channels, enabling the formation of undercut banks (excellent fish habitat) and reduces erosion (fine sediment smothers juvenile salmonids developing in streambed gravels). Overhanging tree canopies shade water, maintaining the cool temperatures salmonids need to thrive. Leaf litter falling into the stream is an important component of primary production within the aquatic community. Insects feed on the decomposing leaves, and fish in turn feed on the insects. Mature trees in the riparian zone also provide important function when they are knocked into streams by windthrow or landslides. These woody materials are known as large woody debris (LWD). Large woody debris stabilizes streambeds and banks, captures spawning gravels, encourages pool formation, provides resting and hiding cover for salmonids, and creates habitat for insects and other forage important to salmonids. Finally vegetation within the riparian zone filters soil and pollutants from stormwater runoff and reduces flood damage by slowing down flood waters, thereby dissipating energy and capturing soil carried in the flood waters. See [Figure 3](#) below.

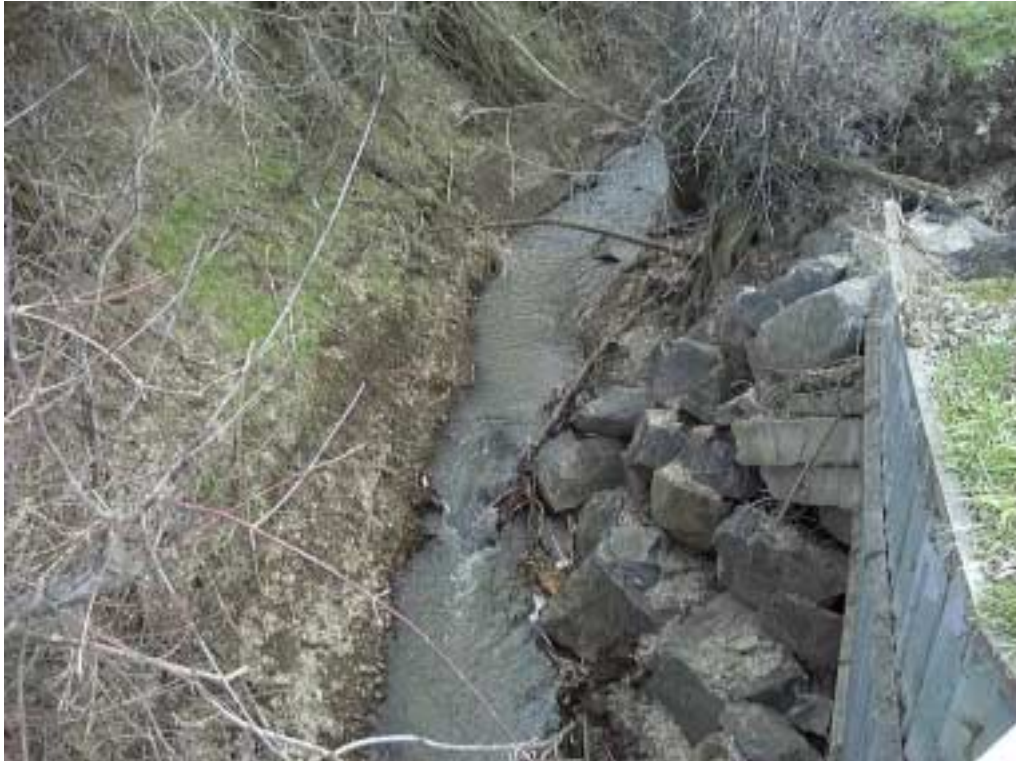
Figure 4. Birch Creek upstream from Powerline Road showing both highly unstable vertical banks and very stable riprap bank protection that is of little value to salmonids. Photo taken January 2001.

salmonids. Eroding streambanks also contribute large amounts of fine sediment to the water column. See [Figure 4](#) below. Fine sediment makes it difficult for adult salmonids to breathe and smothers juvenile salmonids hiding in the gravel on the bottom of streams. Once the sediment settles to the bottom it cements gravels and cobbles together forming a type of “pavement.” This pavement makes it difficult for female salmonids to excavate their nest or redd. An abundance of fine sediment reduces the amount of water able to circulate through the gravel deposited over the eggs in the redd. This water infiltration is critical to oxygen delivery to the developing salmon and removal of fish wastes from the nest.

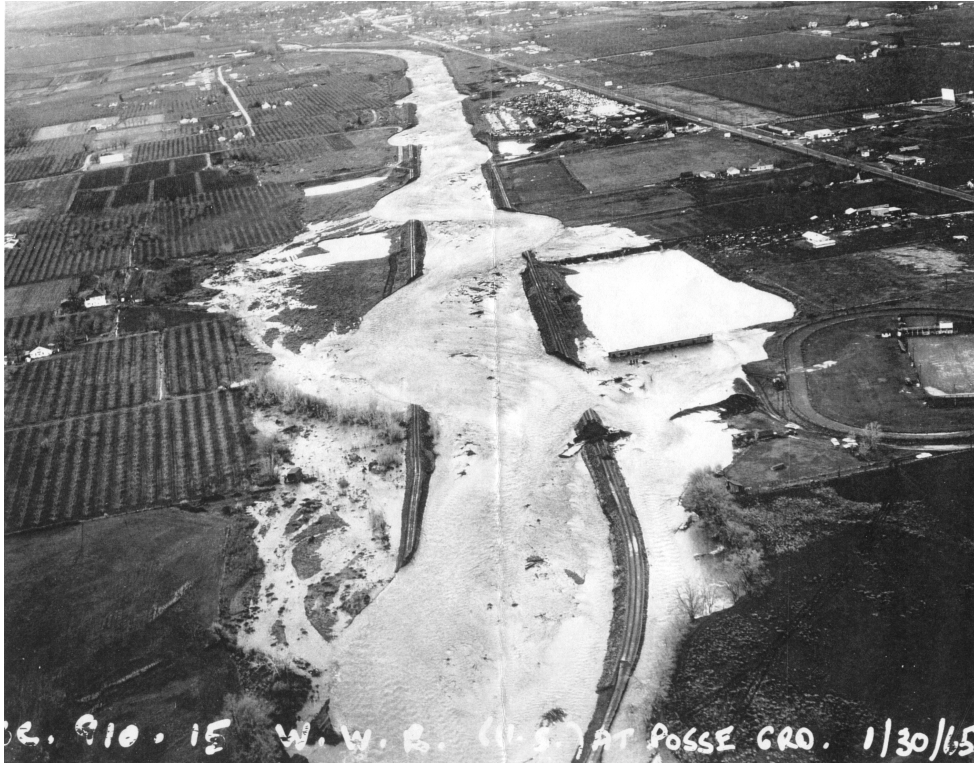
Figure 5. Walla Walla River downstream from Milton Freewater, OR 1965. Flood waters burst through the dikes attempting to reestablish a meandering channel and reclaim the floodplain. Photo courtesy of U.S. Army Corps of Engineers, Walla Walla District.

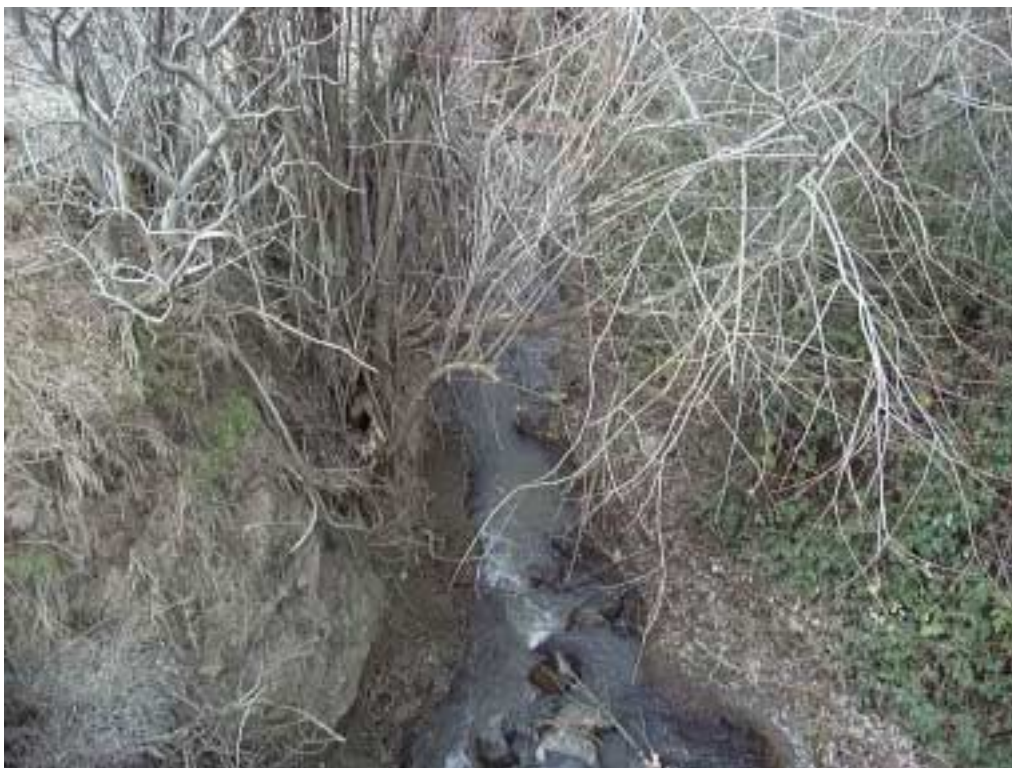
Figure 6. Birch Creek below Powerline Road showing a narrow width/depth ratio caused by highly unstable banks. Photo taken January 2001.

The width/depth ratio refers to the average width of the river channel at a given cross-section divided by the average depth at that same cross-section. In other words it determines if the channel is wide and shallow (high width/depth ratio) or narrow and deep (low width/depth ratio). In general a narrow deep channel is more favorable to salmonids than a wide shallow channel. The deep water provides hiding cover and maintains cool water temperatures. While shallow water provides little or no cover (depending upon the life stage) and tends to gather heat with the expansive surface area exposed to the sun. The width/depth ratio also provides clues about a river's current state of channel evolution. A low width/depth ratio indicates a stable channel that has reached the end point of channel evolution, or possibly an unstable channel that is downcutting rapidly in response to channel disturbances elsewhere within the watershed. Conversely a very high width/depth ratio usually indicates unstable streambanks and rapid deposition of sediments. This situation might naturally occur at a river outlet or delta area, or it could be a response to channel disturbances upstream or downstream (Rosgen 1996). See [Figure 6](#) below.

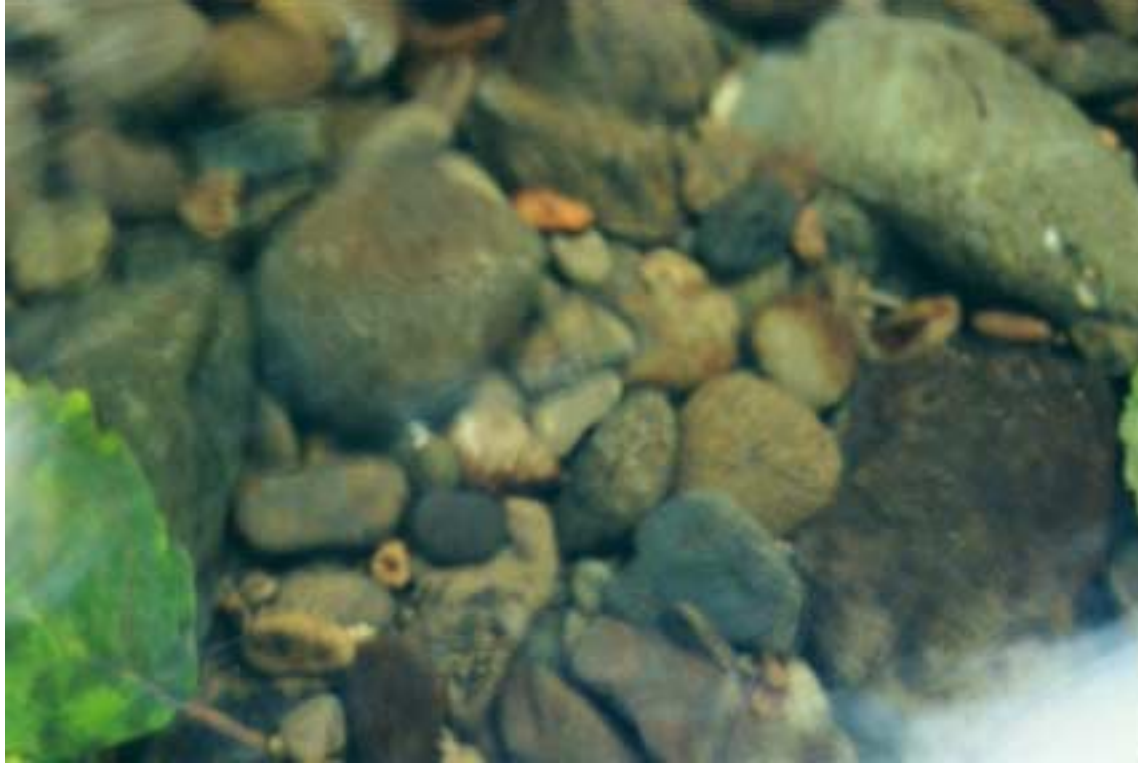
Figure 7. Clean-unembedded gravel provides excellent salmonid spawning habitat.

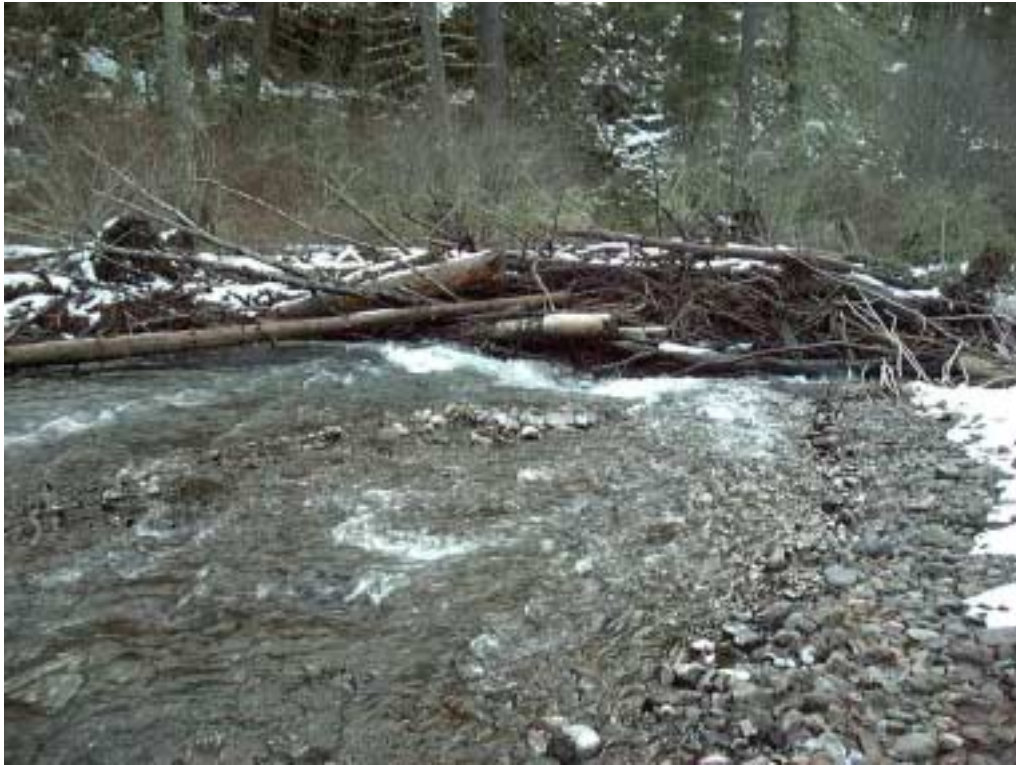
Figure 8. Large woody debris jam on the South Fork Walla Walla River on Bureau of Land Management Lands. Photo taken January 2001.

Large woody debris or (LWD) is an important component of stream habitat. Large trees that fall into streams, or are carried in by landslides and floods stabilize streambeds, collecting spawning gravels and encouraging pool formation. Woody debris also provides cover for salmonids and their prey. See [Figure 8](#) below. In the past woody debris was removed to aid navigation, transport logs downstream, speed flood waters downstream, or remove barriers to salmonid migration. Large woody debris is lacking in many streams because of these activities. Unfortunately woody debris recruitment is a long-term process since it requires the presence of a functioning riparian zone comprised of numerous large trees.

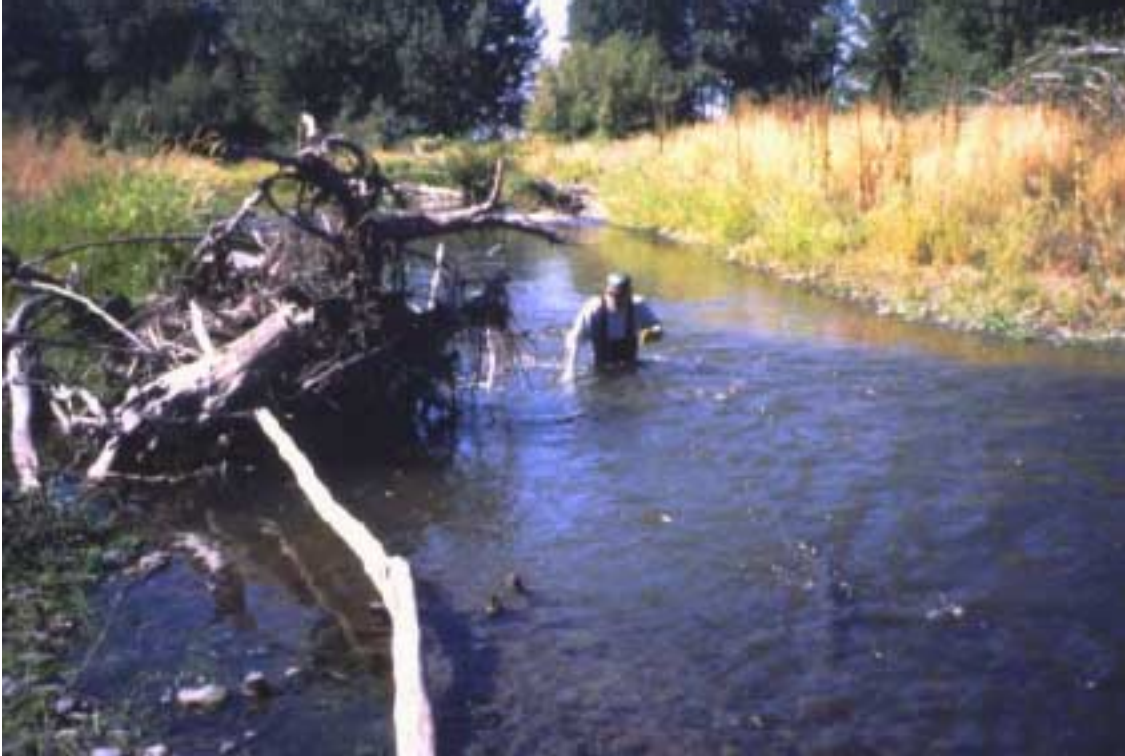
Figure 9. Quality pools are deep (up to waist in this case) and have instream and overhead cover. The rootwad provides both types of cover in this case. Photo courtesy of Ben Tice, USACE, Walla Walla District. Photo taken 1999.

Important features of pools are size, depth, and cover (instream and overhead). Generally speaking the more size, depth, and cover that are present the higher the quality of the pool. Large-deep pools with lots of cover provide many hiding areas, ample forage, and cool water temperatures. An abundance of pools interspersed with riffles combine to create ideal salmonid habitat. See [Figure 9](#) below.

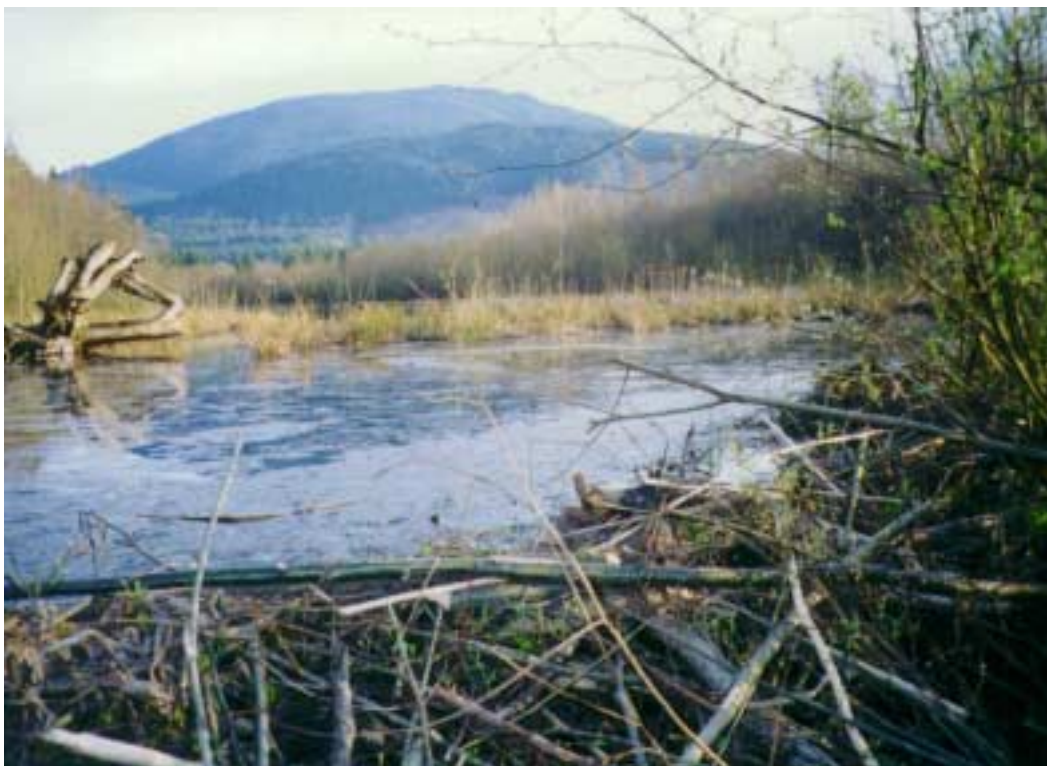
Figure 10. Beaver ponds provide excellent off-channel rearing habitat for salmonids. Today beaver populations are depressed in the Walla Walla Basin.

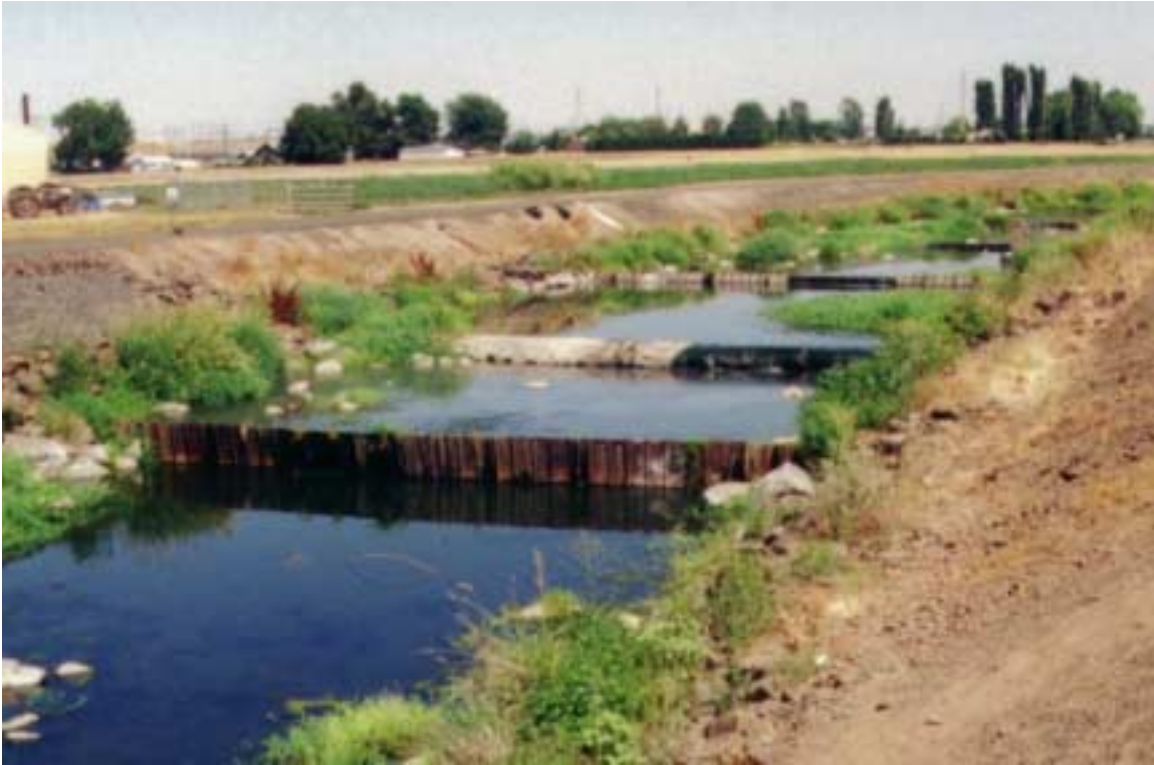
Figure 11. Mill Creek above Gose Road during summer low flows. Fish cannot migrate through this reach, so those present likely perish from high water temperatures or predation. Photo taken summer 2000.

irrigation water withdrawals. In several reaches streams are reduced to a trickle or completely dewatered. If flows are too low or channels are completely dewatered, little or no quality habitat remains for salmonids. As flows decrease, water temperatures increase. Migration is hindered or completely blocked and fish are more vulnerable to predation. See [Figure 11](#) below.

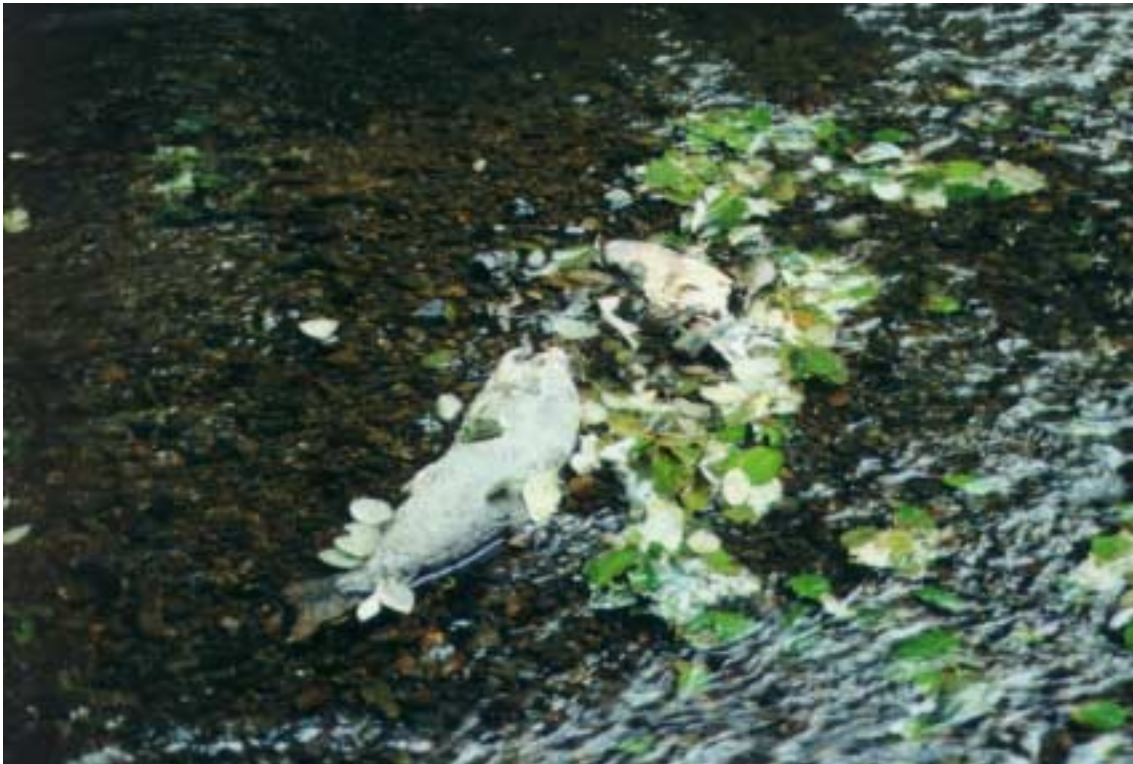
Figure 12. Decomposing anadromous fish carcasses provide ocean-derived nutrients to freshwater ecosystems.

vegetation, reducing the quality of riparian plant communities. The removal of species can disrupt ecosystem functions. For example, beaver historically impounded many portions of streams in the watershed. Beaver ponds are excellent salmonid rearing habitat and they gradually release water to streams, helping to maintain summer flows. Large numbers of anadromous salmonids returning from the ocean are a valuable source of nutrients to the upper portions of watersheds which are often nutrient limited. Nutrients from decomposing salmon carcasses are a critical component of the aquatic food chain. Anadromous fish populations are depressed, therefore anadromous fish carcasses are well below historic levels in Walla Walla Basin streams (Mendel, G. 2000 Personal Communication). See [Figure 12](#) below.

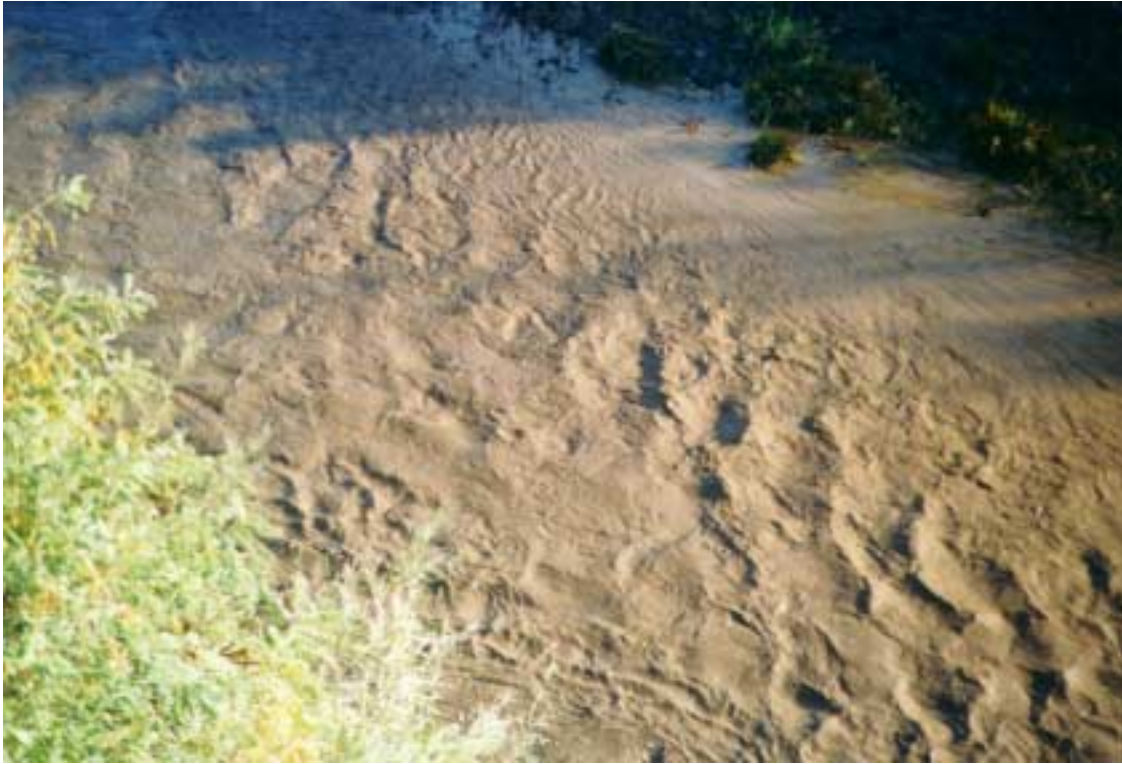
Figure 13. Muddy Touchet River water at Cummins Road Bridge following an early October 2000 rainstorm.

rate.) (USDA Soil Conservation Service *et al.* 1984). Substrate embeddedness becomes progressively worse as one moves downstream. See [Figure 13](#) below.

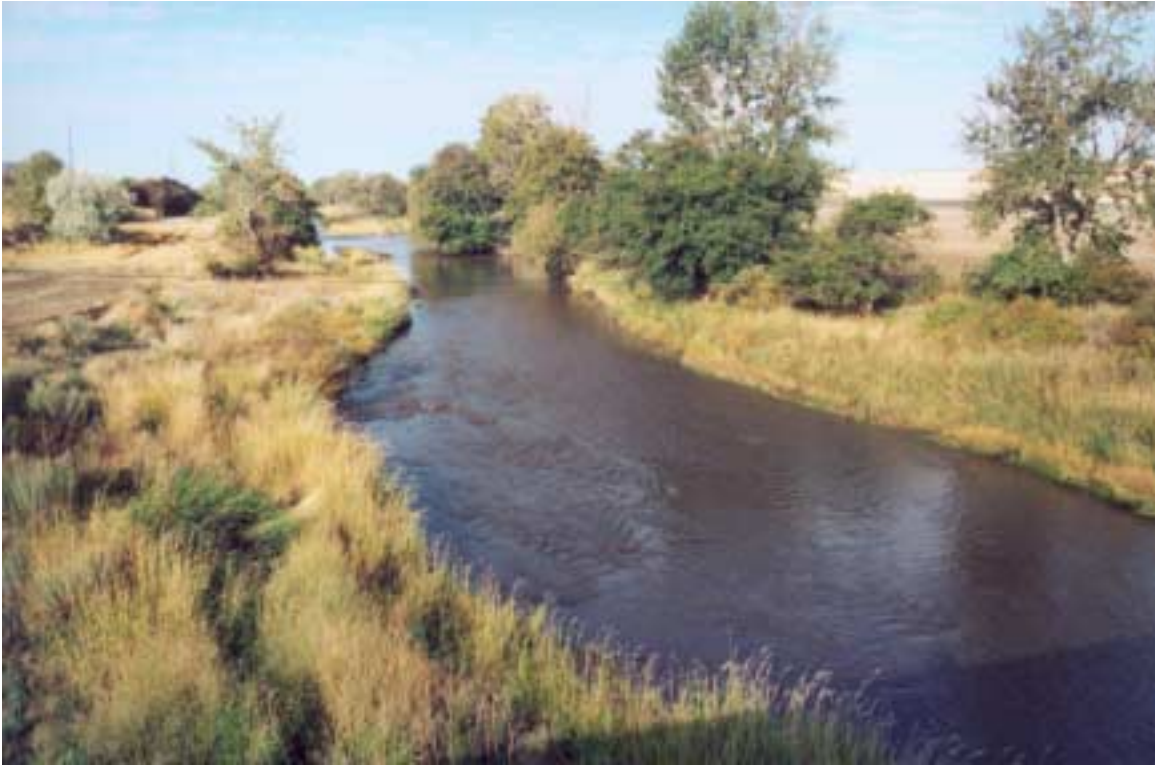
Figure 14. Touchet River at Pettyjohn Road. The riparian vegetation in the photo is representative of the reach from Coppei Creek to Hwy. 125. Photo taken October 2000.

The riparian zone along this reach has been changed substantially from historic conditions, but it is still providing some function. Reckendorf and Tice(2000) describes the riparian zone as a narrow buffer with minimal mature trees, but providing some shade. See [Figure 14](#) below.

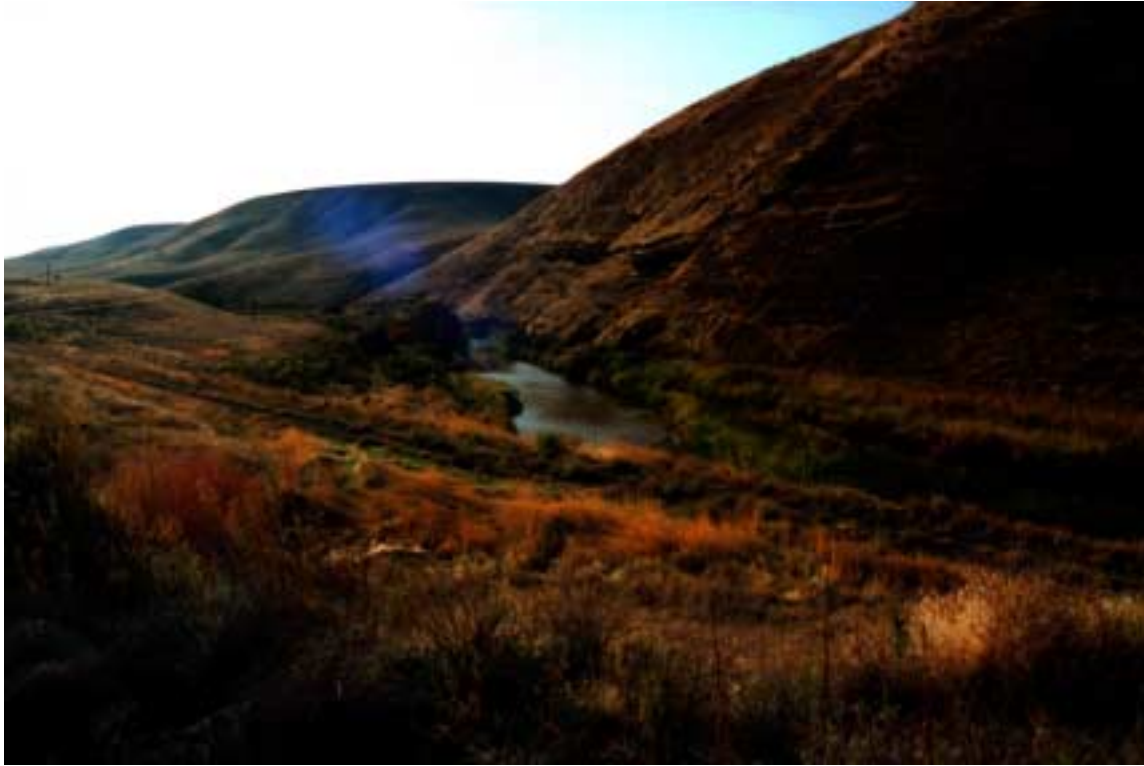
Figure 15. Touchet River at Lamar. The riparian vegetation in this photo is representative of the condition from Hwy. 125 to the mouth. Photo taken October 2000.

Trees are a rare sight in the riparian zone of this reach, especially mature trees. Where present they occur in a very fragmented distribution of one or two trees per patch. Much of the reach can be viewed by driving along Touchet North Road and State Highway 124. See [Figure 15](#) below.

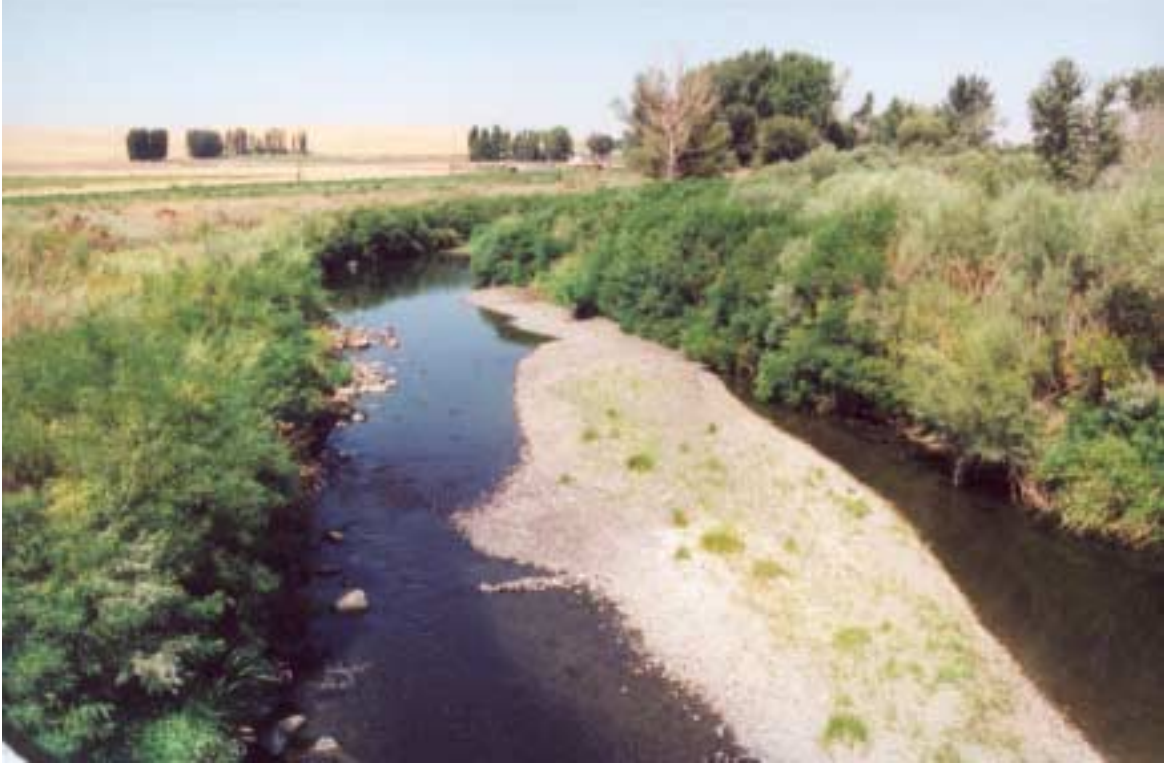
Figure 16. Touchet River at Cummins Road during the summer of 2000.

Flows are inadequate to allow salmonid passage from Hofer Dam (RM 5.0) downstream to the mouth during the summer and early fall months. This reach is often reduced to a series of isolated pools as the majority of water is diverted from the mainstem Touchet at Hofer Dam to agricultural fields (Mendel *et al.* 1999; Saul *et al.* 1999). See [Figure 16](#) below.

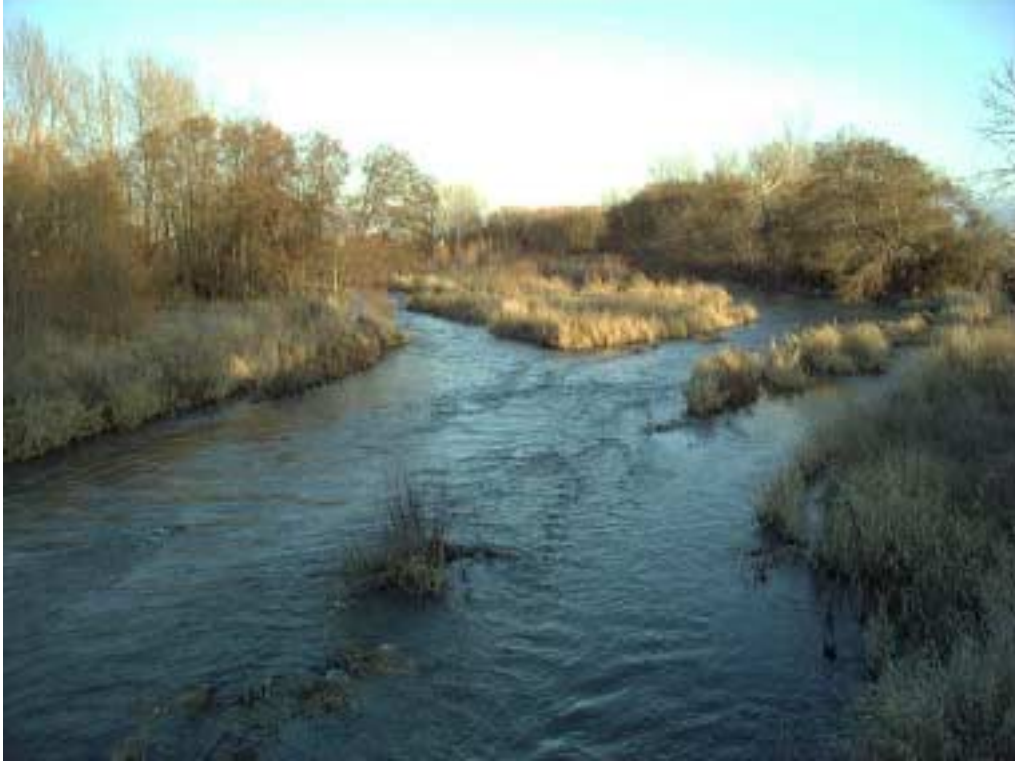
Figure 17. Walla Walla River above Last Chance Road. Photo taken in early February 2001.

Riparian vegetation along this reach is composed of a diverse mix of deciduous trees including cottonwood, alder, birch, and willows. The buffer varies in width depending upon land ownership, but is generally narrow (Kuttel 2001). See [Figure 17](#) below.

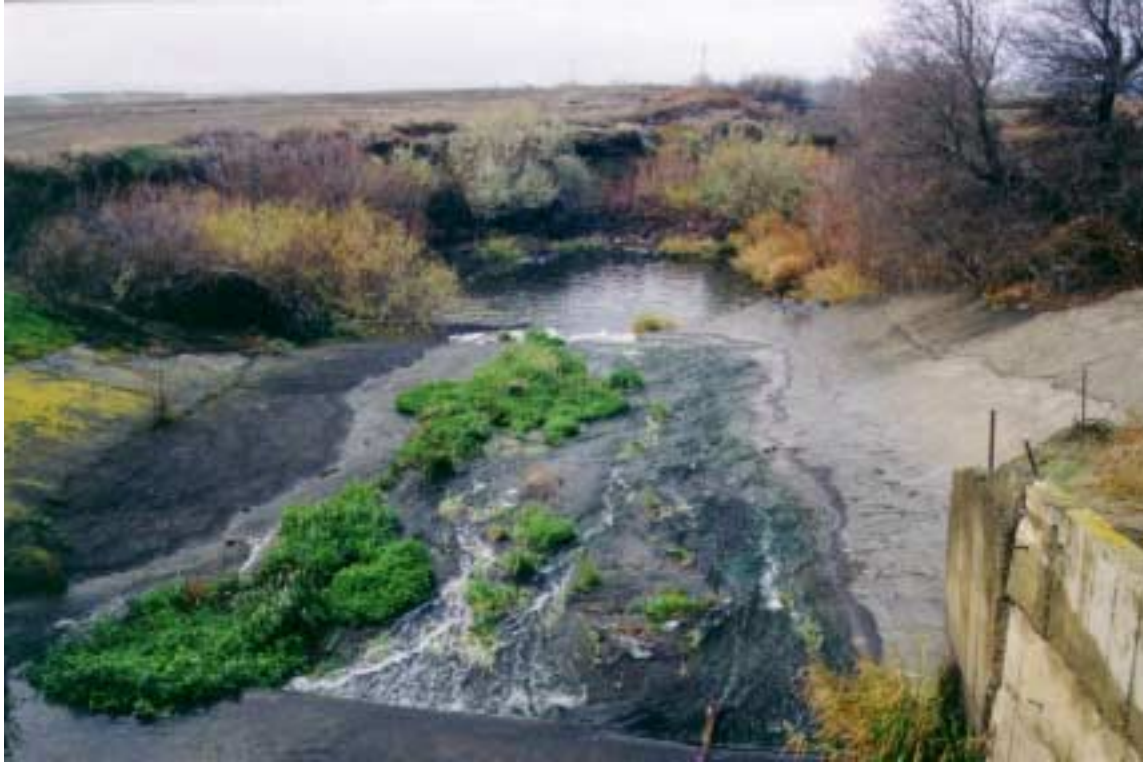
Figure 18. Grade control structure below Hudson's Bay Road on Pine Creek (Oregon). Photo taken fall of 2000.

No barriers have been identified on the Washington portion of Pine Creek (TAG 2000 Personal Communication). However, a grade control structure at approximately RM 7.0 in Oregon is a substantial barrier. See [Figure 18](#) below. Abandoned check dams and other structures are suspected to be prevalent throughout these streams (TAG 2001 Personal Communication).

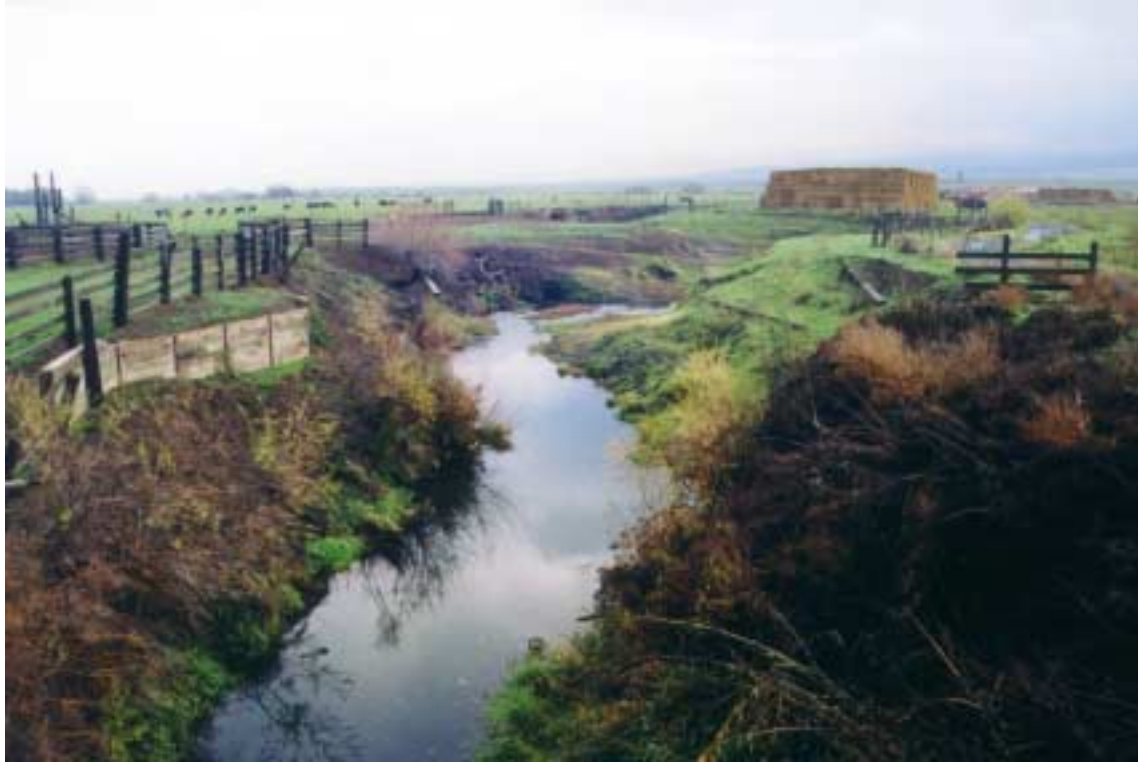
Figure 19. Pine Creek upstream from Stateline Road. Photo taken fall of 2000.

Channel incision limits floodplain connectivity (Bureau of Reclamation 1997). See [Figure 19](#) below.

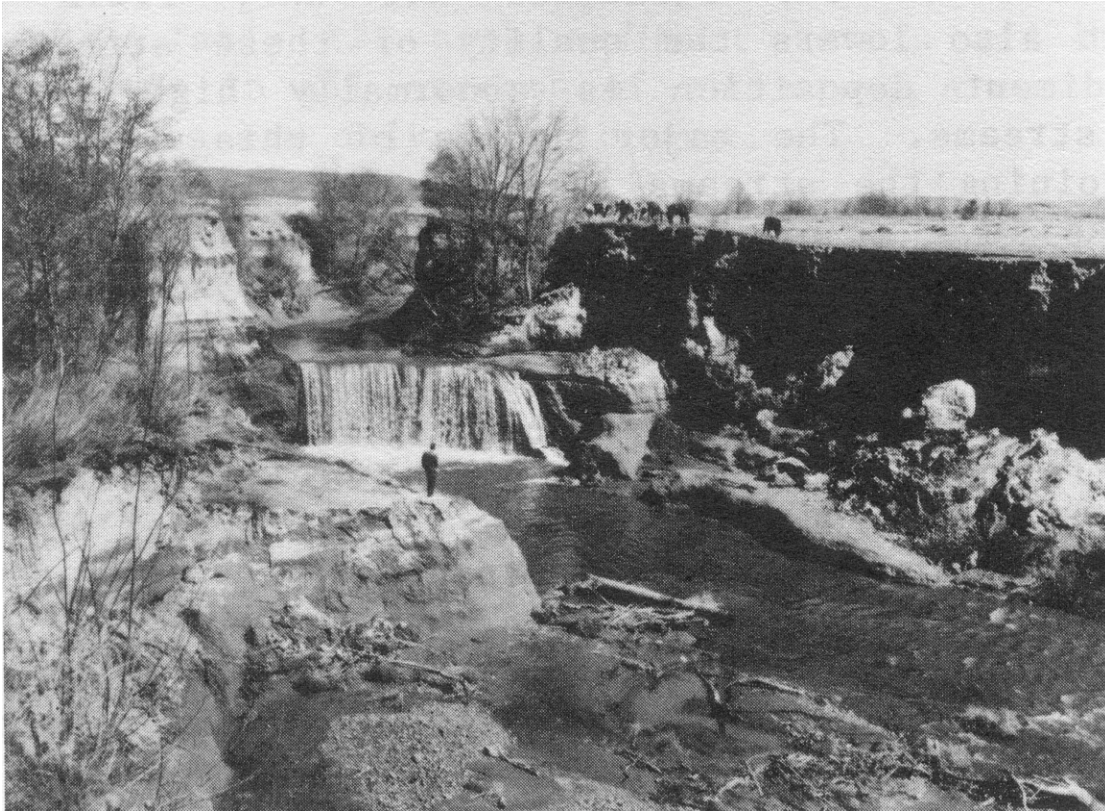
Figure 20. Dry Creek Falls showing severe channel incision. Source: USDA Soil Conservation Service *et al.* 1984. Photograph date unknown.

bank of Dry Creek (looking downstream) are deeply incised and likely make significant contributions of fine sediment to the system (TAG 2000 Personal Communication). [Figure 20](#) below illustrates the severity of channel incision on Dry Creek.

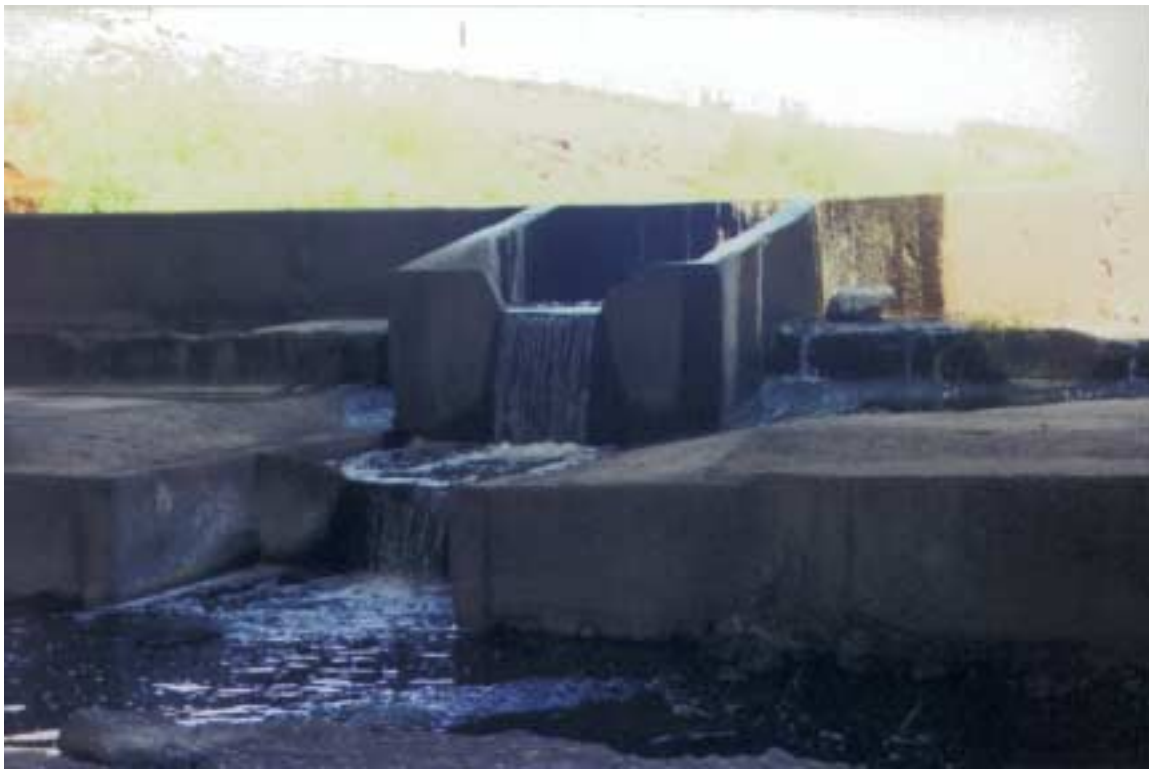
Figure 21. Grade control structure under Gose Road Bridge over Mill Creek. Photo taken summer of 2000.

U.S. Army Corps of Engineers (1997) lists three full channel spanning and three partial channel spanning barriers on this reach. A grade control structure located at Gose Road bridge is a barrier (Montgomery Watson 1999). See [Figure 21](#) below. Mill Creek has been channelized since 1948 from Bennington Lake Diversion Dam downstream to Gose Road (U.S. Army Corps of Engineers 1988). See [Mill Creek Channel Diagram](#). The upper and lower portions of this wide channel are characterized by riprapped banks and cross weirs spaced about every 100 feet. The middle portion of the channel (through the City of Walla Walla) is concrete lined with a low flow channel and baffles placed at regular intervals in an attempt to allow fish passage. See [Figure 22](#). The channelized reach goes dry (or nearly dry) about a mile below Bennington Lake Diversion Dam (just below the Yellowhawk/Garrison Creek division dam) during the summer months as a result of flows being diverted to Yellowhawk and Garrison Creeks. Juvenile passage is likely impeded through this reach during both low and high flow conditions (impassable during summer months because of dewatering) (TAG 2000 Personal Communication).

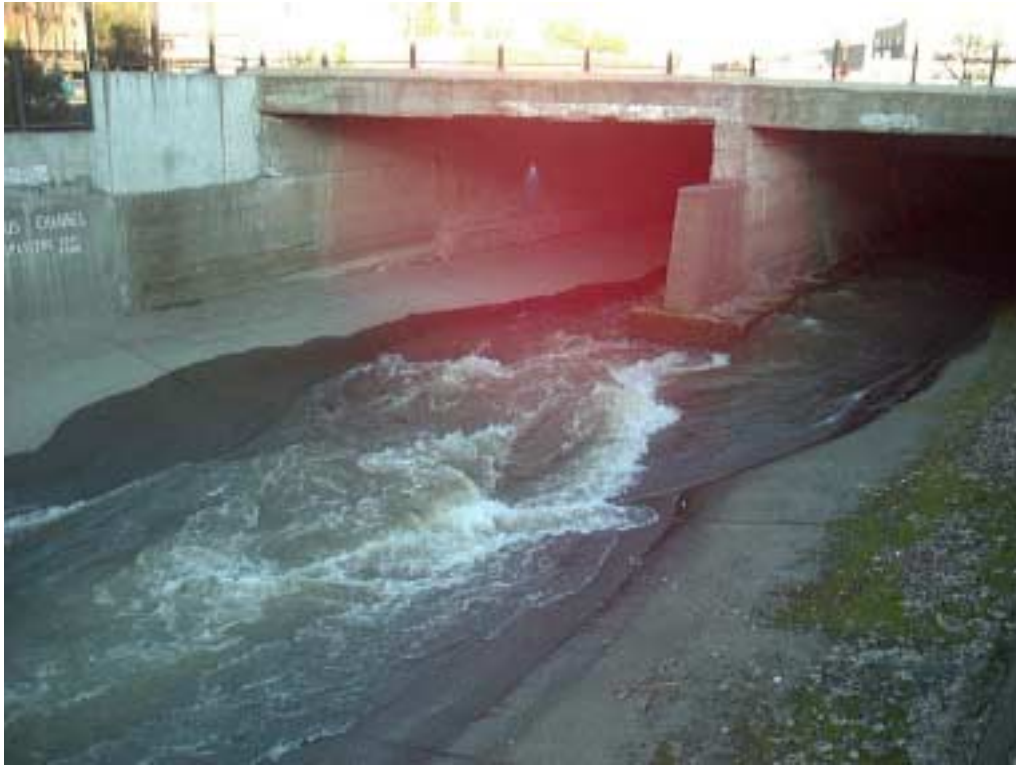
Figure 22. Mill Creek below 3rd. Avenue in Walla Walla. Photo taken February 2001.

The Mill Creek flood control project confines the channel with riprap and concrete lined banks, thereby preventing natural channel evolution processes (lateral migration, meandering, floodplain inundation, large woody debris recruitment, etc.). This type of man-made bank stability provides little to no fish habitat value (Northrop 1999, U.S. Army Corps of Engineers 1997). Streambanks on this reach do not erode, but they are of little value to salmonids. See [Figure 22](#) below.
